Historic Lighthouse Preservation Handbook

1997

Introduction

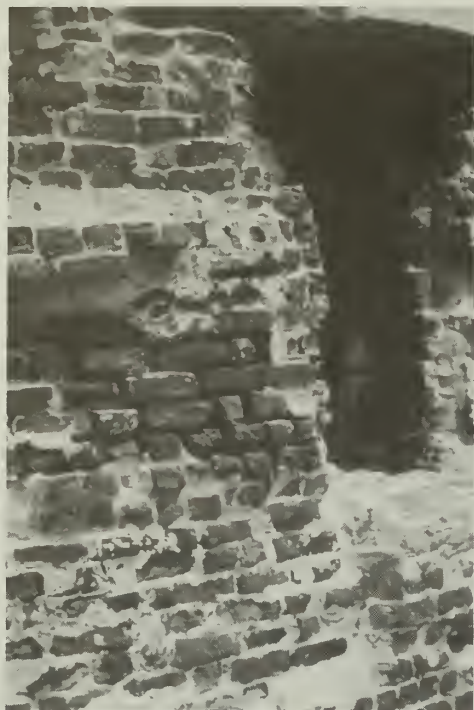
Figure 25. View of the lower portion of the tower showing the more severe deterioration. Note that a large percentage of the first brick wythe is missing or has been removed. The white areas are remains of a portland-cement-based parging applied in the late 1960s in an effort to protect the deteriorating bricks.

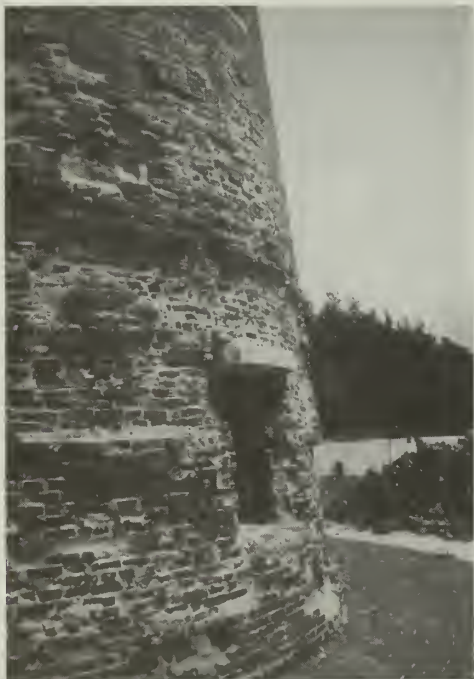
Figure 26. View of the lower tower window; note the depth of the brick deterioration at the window openings. The face of the protruding granite lintel above the window opening represents the face of the original wall.

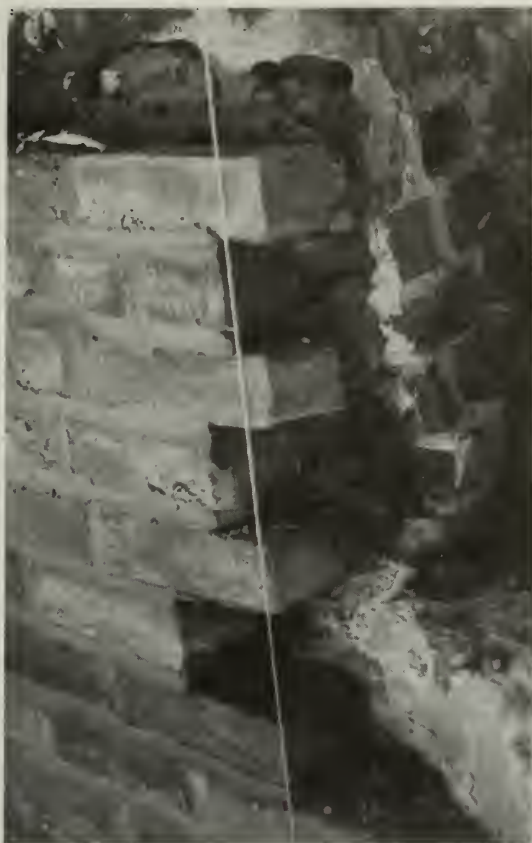
Figure 27. View of repairs being made to the exterior wall. A new brick wythe is being installed where bricks were missing, using mortar that matches the strength of the new and historic bricks. Masonry anchors are used to attach the new wythe to existing wall. The deteriorated mortar joints in the extant wall were repointed with a matching mortar mix.

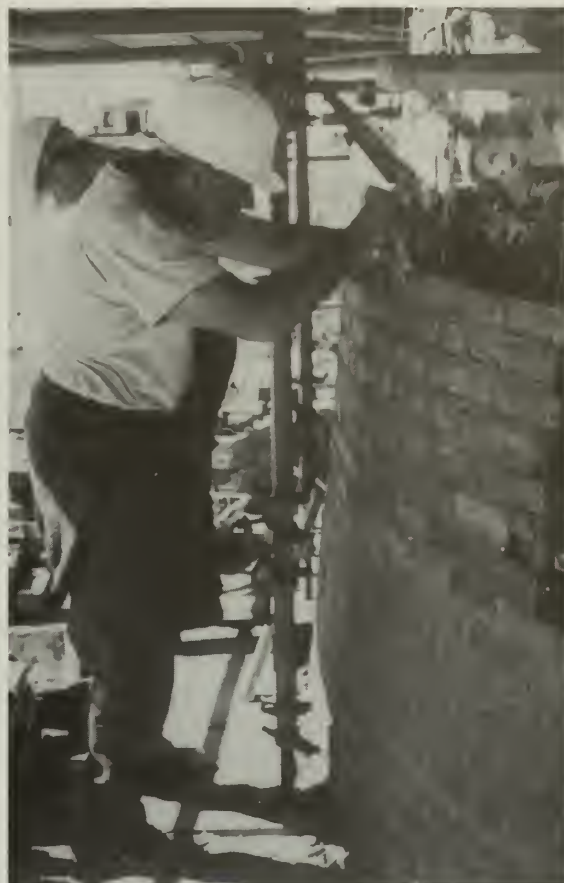
Figure 28. Here a mason is implementing repairs to the exterior wall. The missing bricks were replaced with in-kind materials: the bricks match the historic bricks in size shape and strength. The mortar joint sizes are also being made to match the historic in size, color, and texture, as demonstrated in this photo. The vertical strings over the brickwork define the wall plane, so when the mason places the bricks, they maintain the taper of the conical tower.

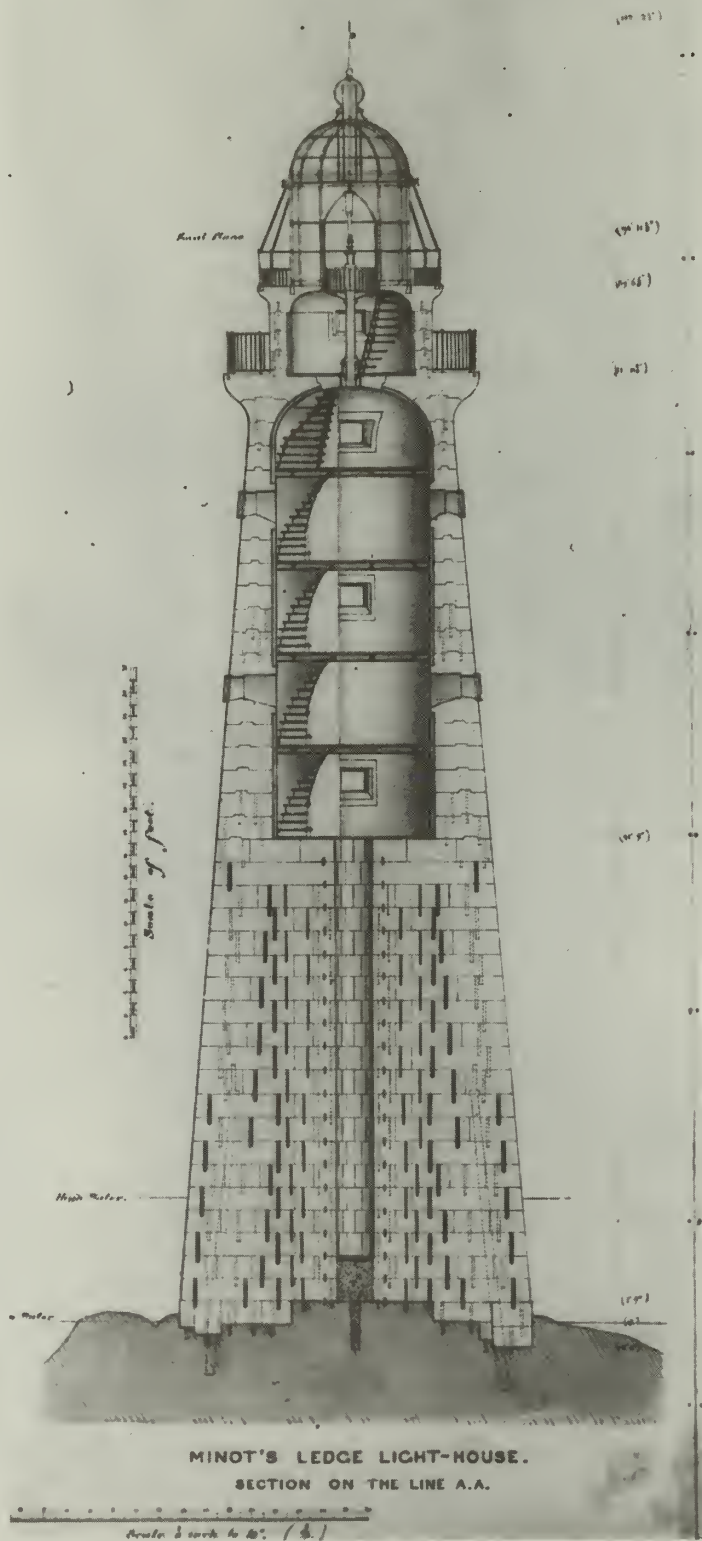
Figure 29. Cross section for 114-foot Minots Ledge Lighthouse.

On August 31, 1852, Congress approved the erection of the second and still standing lighthouse on the “Outer Minots rock.” This time the design chosen was one of interlocking granite blocks. The plans consisted of a masonry tower in the form of a frustum of a cone, solid for the lower 40 feet of its 114-foot height. Because the ledge was exposed only at low tide and on calm days, the work was very slow. Tides were found to be right only “six times during any one lunation, three at full moon and three at the change.” It took three years to prepare the ledge for the first course of granite masonry which was cut and test assembled on nearby Gulf (later called Government) Island, near Cohasset, where the government acquired 7.3 acres of farmland for a staging area for the building of the second lighthouse. Here stone-sheds were erected for the stone cutters and a perfectly flat pavement prepared so the stones once cut could be pre-assembled for correct fitness. Granite from Quincy was chosen as being “finest of grain, toughest and clearest of sap.” An iron scaffold was erected on the ledge for the safety of the

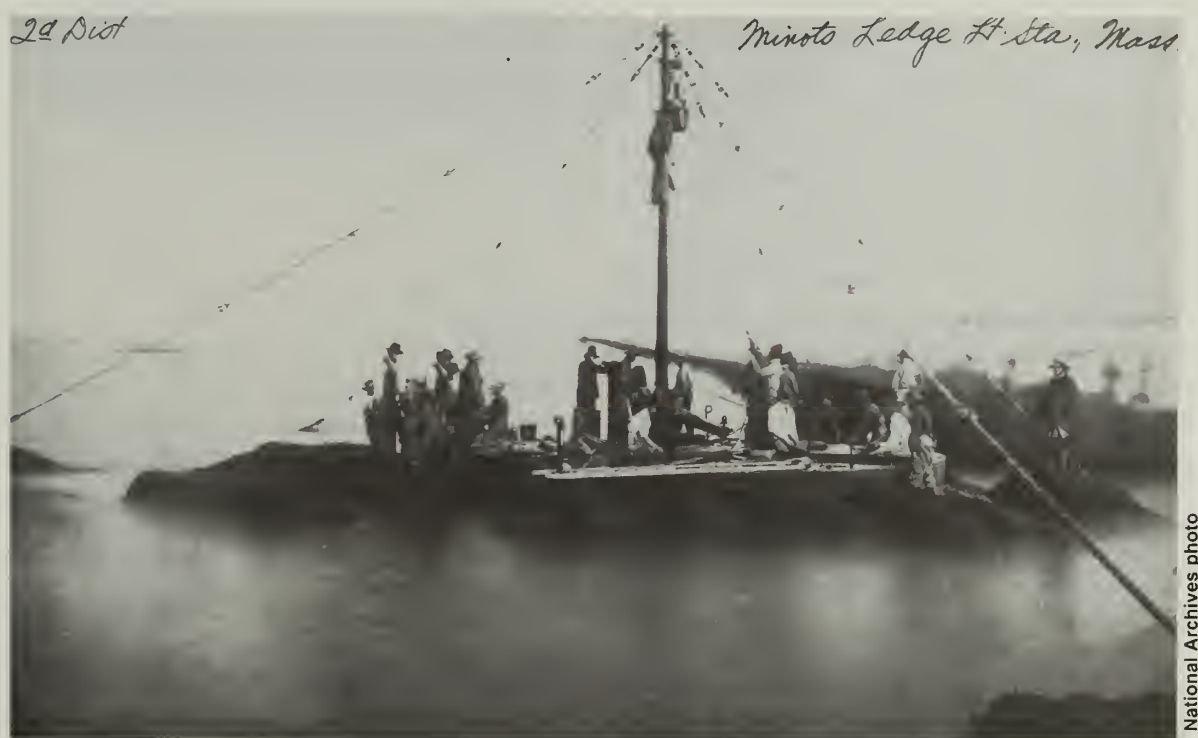
Figure 30. Workers on a calm day, completing the first course of granite block for the foundation of Minots Ledge Lighthouse, 1858

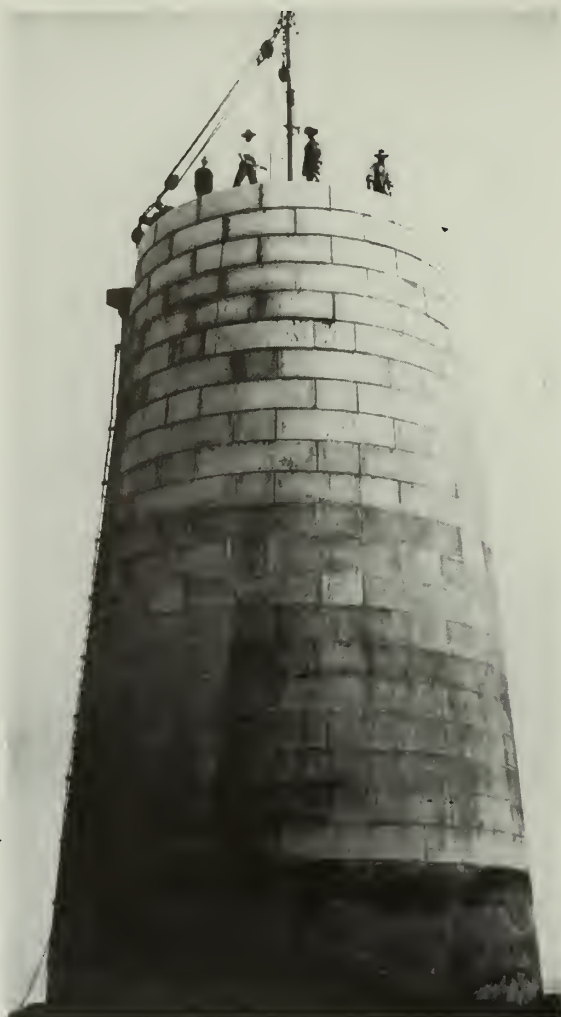
Figure 31. Work on Minots Ledge Lighthouse as it progressed just above the entrance level which is visible on the left. The tower below this level was essentially solid.

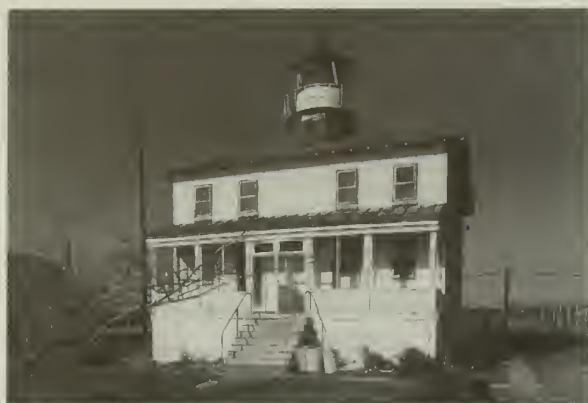
Figure 2. Example of a keeper's quarters fitted with a prefabricated cast-iron-and-steel lantern.

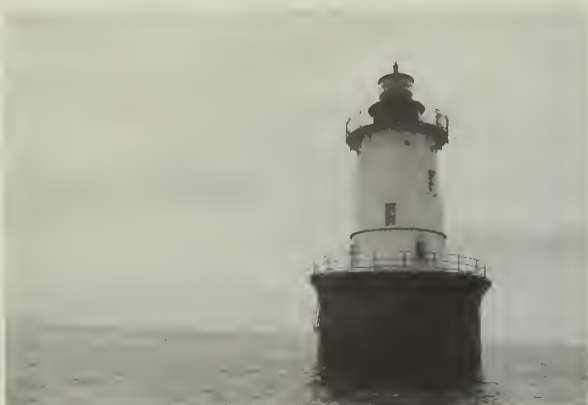
Figure 3. Example of an all-cast-iron construction "sparkplug" caisson-style lighthouse.

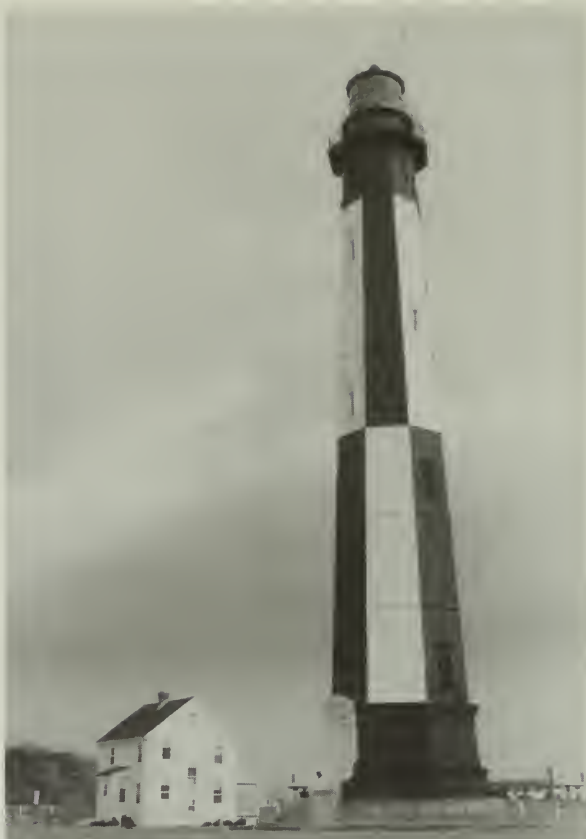
Figure 4. Double-wall, cast-iron, first-order 163-foot-tall coastal tower at Cape Henry, Virginia.

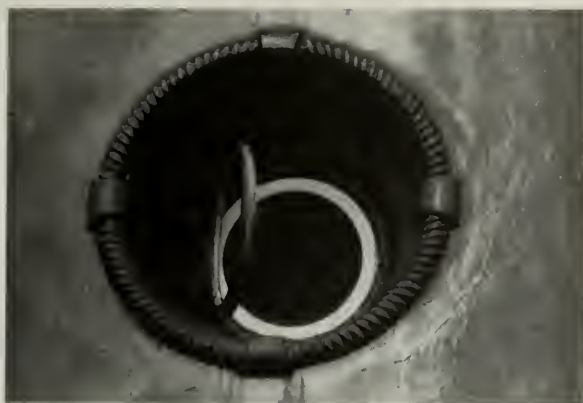
Figure 5. A view of decorative-rope nautical-style cast-iron window surrounds on Cape Canaveral Lighthouse.

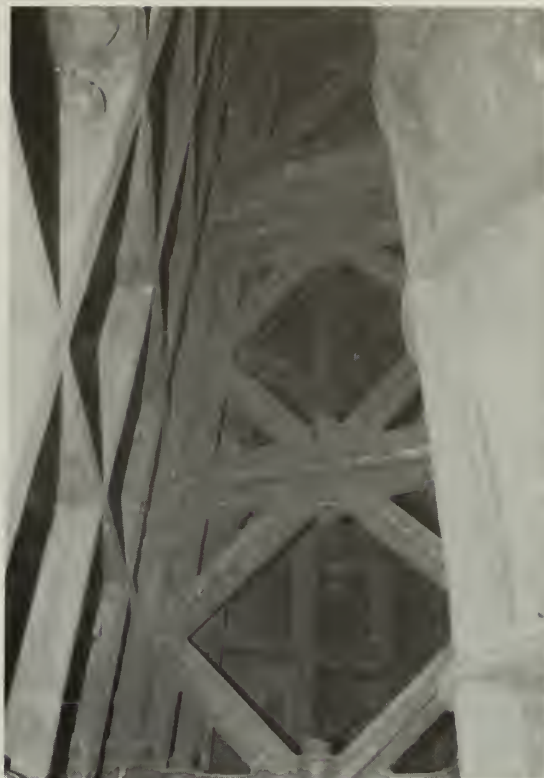
Figure 6. A view of the inner cavity and skeletal structure of the Cape Henry Lighthouse.

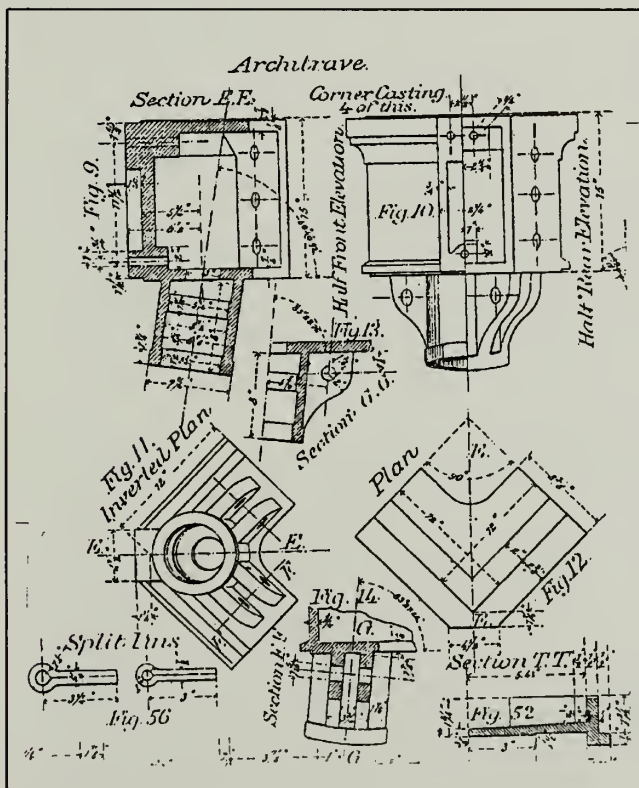
Figure 7. Shop drawings used for the production of cast-iron lighthouse parts for a screwpile lighthouse.

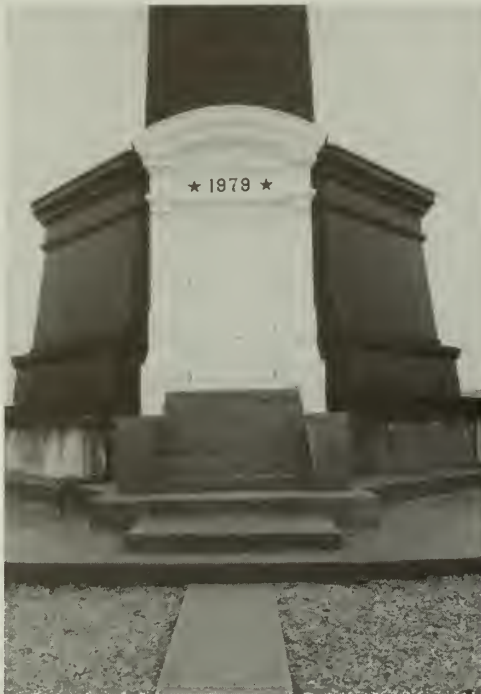
Figure 8. An example of the level of detail achieved with cast-iron construction.

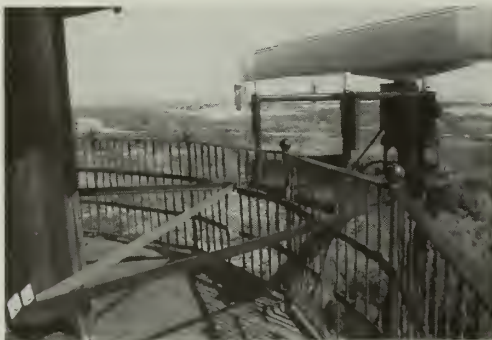
Figure 9. A modern range finder attached to the gallery deck using modern steel members.

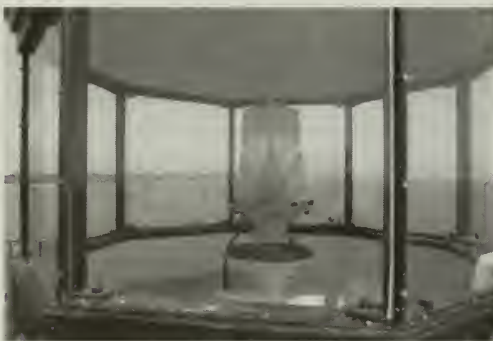
Figure 10. Close-up of a lantern glass frame: note the use of stainless steel bolts; the lower clamps are also stainless steel that have been painted black.

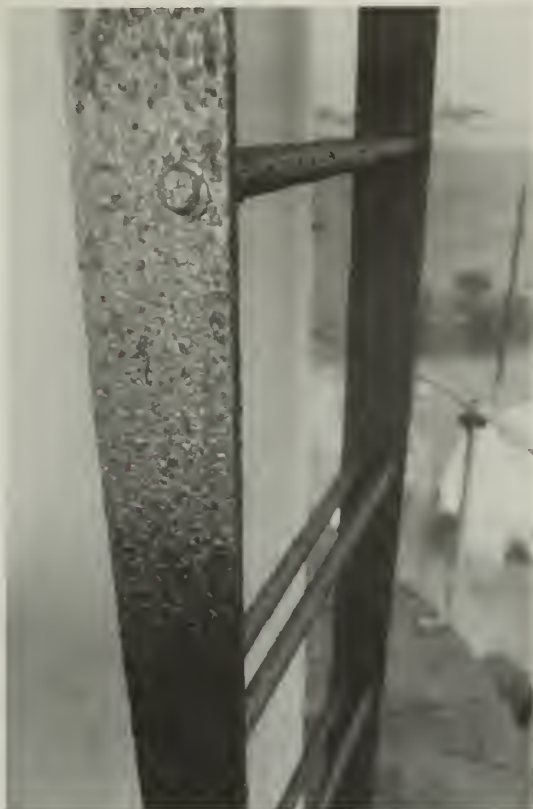
Figure 11. Detail view of a steel ladder that has been uniformly attacked by corrosion.

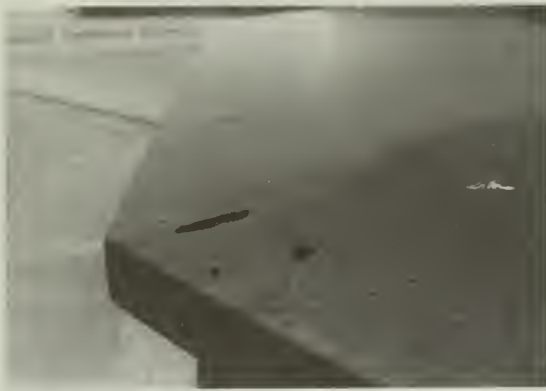
Figure 12. Close-up of localized corrosion or pitting where the corrosion has eaten through the cast iron.

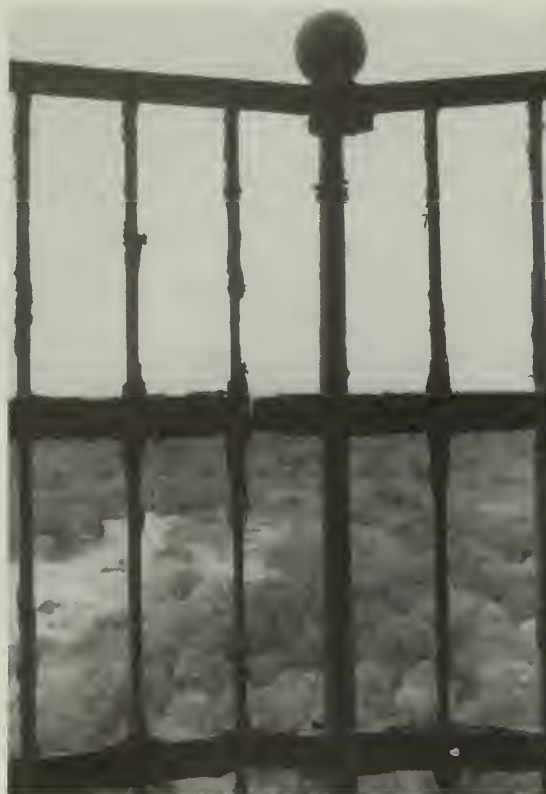
Figure 13. View of a steel railing where corrosion has occurred in distinct locations either because of variations in composition or localized failure of the coating system.

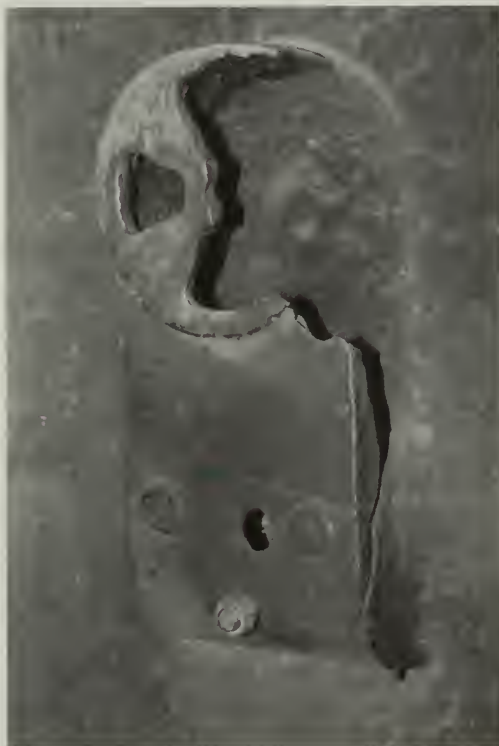
Figure 14. Nearly 30% of this ventilation shroud has been lost to two forms of abrasion: first, sand or grit blasting abraded away a majority of the material; second, human touch has smoothed the once rough surface.

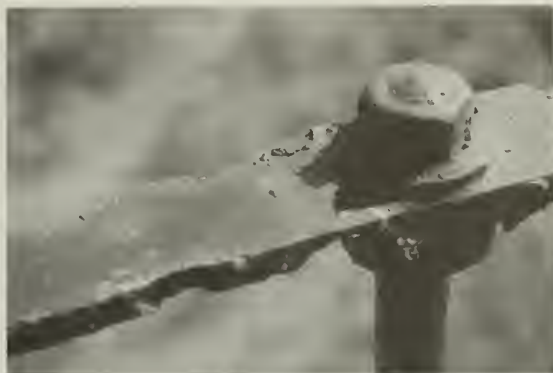
Figure 15. As corrosion attacked this steel handrail, wind and airborne sand eroded the loose and flaking surface rust.

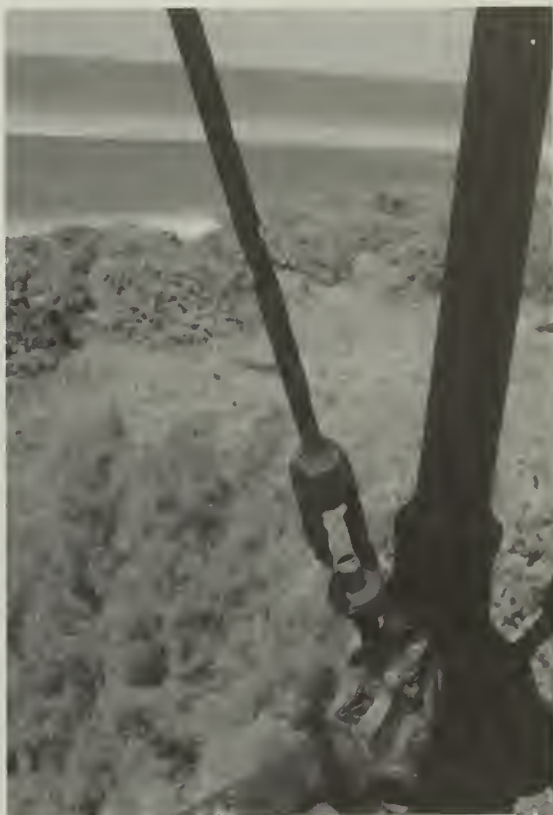
Figure 16. As corrosion attacked this steel turnbuckle, wind and airborne sand eroded away the flaking rust.

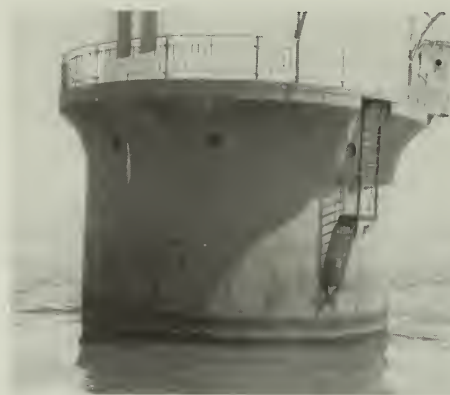
Figure 17. The cyclic pressure of the different rates of expansion and contraction of the exterior cast-iron plates and the interior brick lining of the caisson-style lighthouse has caused the cast-iron plates to fatigue and crack.

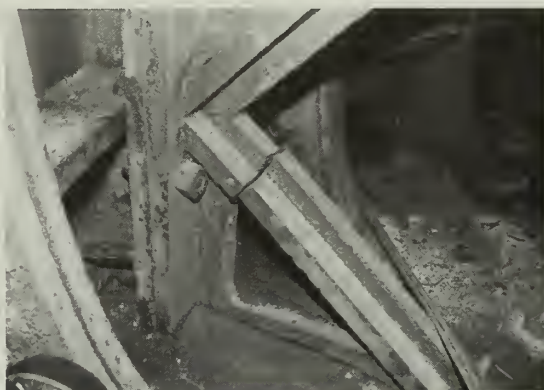
Figure 18. The internal structural skeleton of this lighthouse is cracked because of overloading possibly during assembly.

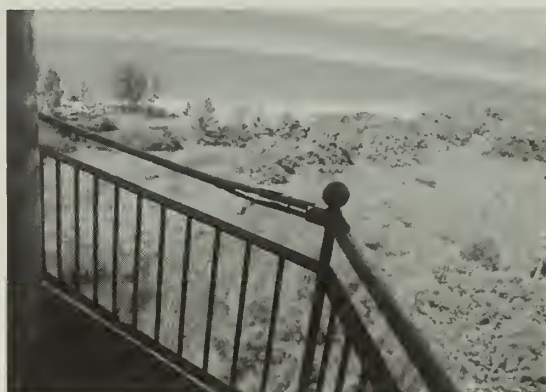
Figure 19. This handrail has been damaged by rust-jacking; rusting began between the two pieces of flat bar stock that formed the rail.

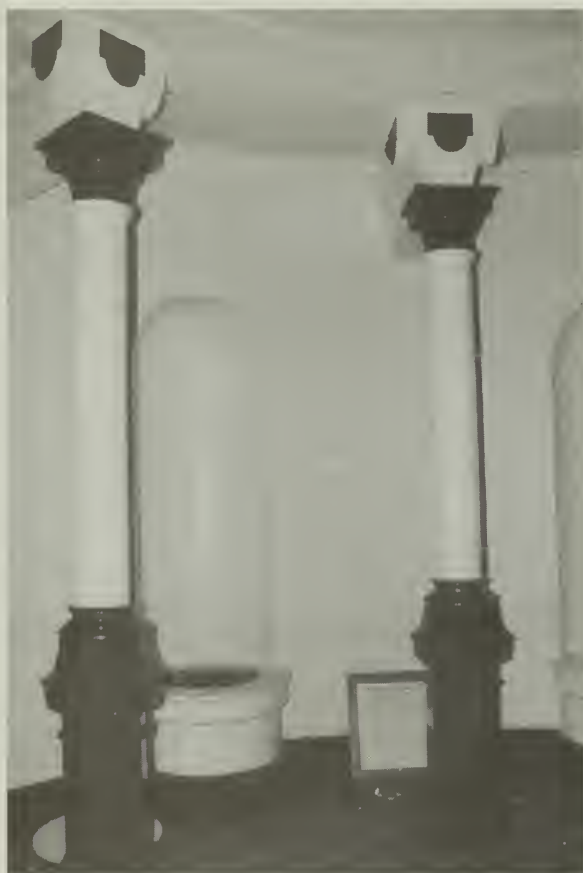
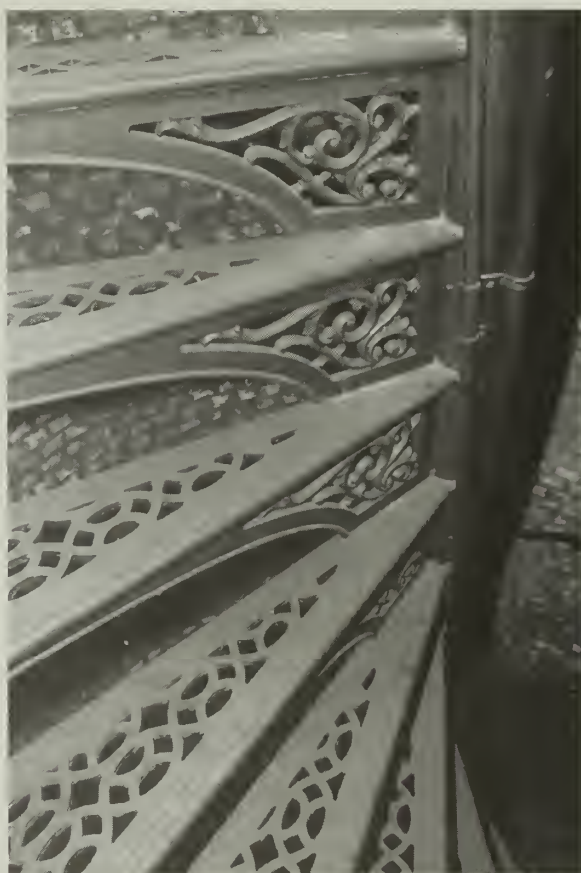
Cast-iron and steel features such as gallery deck brackets, handrails, skeletal structures, pilasters and door pediments, window architraves, as well as textured, finished surfaces such as raised diamond pattern non-skid surfaces, are important in defining the historic character of the lighthouse (see Figures 20 and 21). It is essential that the character-defining features are retained during any treatment. It should also be noted that while cast iron is among the most durable of historic building materials, it is also the most susceptible to damage by improper maintenance or repair techniques and by harsh or abrasive cleaning methods. Therefore, all treatment should be executed using the gentlest means possible. In Part V., **Beyond Basic Preservation**, examples of treatments that are considered rehabilitation and restoration are illustrated and discussed.

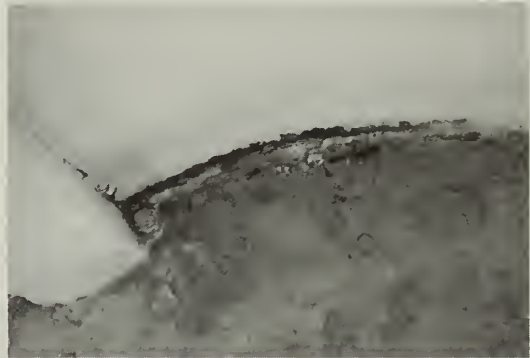
Figure 22. Interior of a sheet-iron parapet wall that is rusting from the inside to out along the lantern room door. This is the result of water entering the interior cavity of the parapet wall.

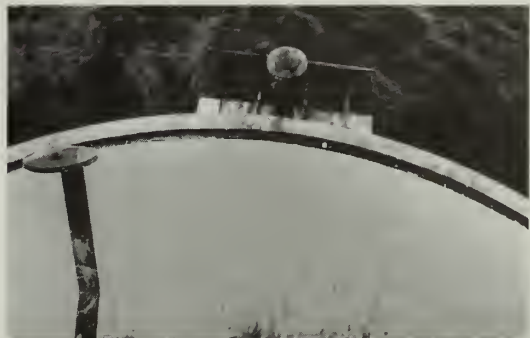
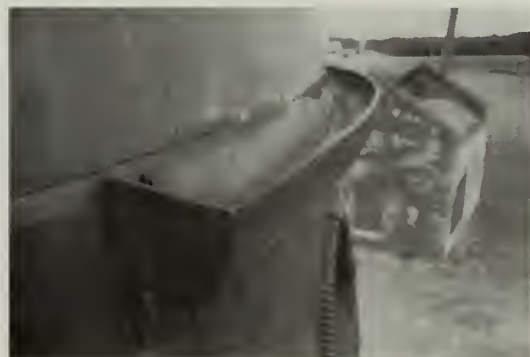
Figures 23 and 24. Two types of gutters found on iron lighthouses; the gutters must be in proper working order and checked regularly during the mothballing period.

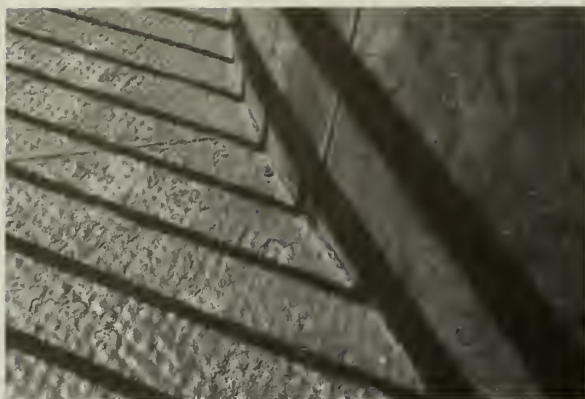
Figure 25. The seams between the deck and wall plates of this lighthouse were not properly sealed; as a result the areas collected water and began to rust.

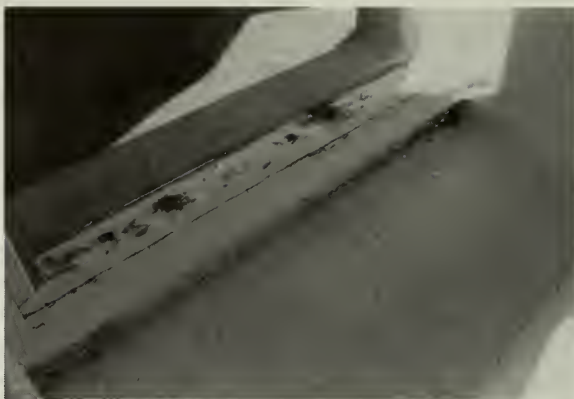
Figure 26. This steel casement window frame was not sealed properly and as a result has begun rusting from the inside out.

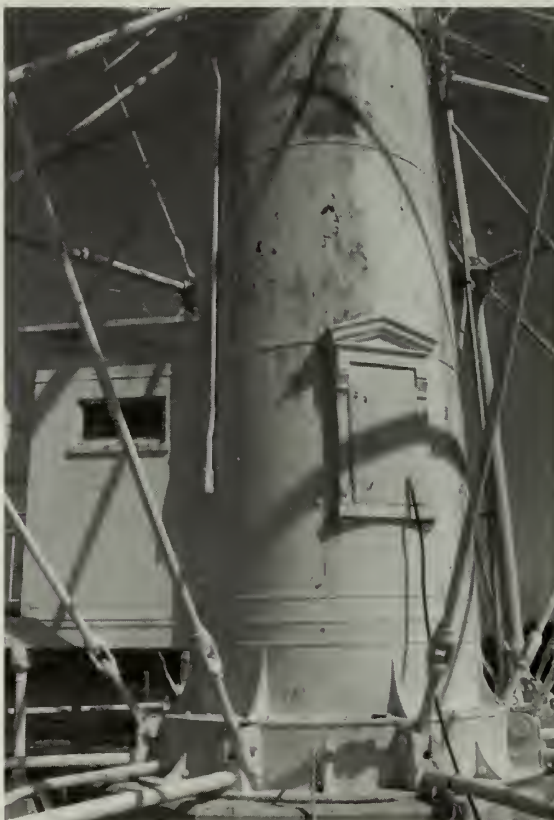
Figure 27. Blistering paint, as pictured here, should be removed and the affected areas properly primed and painted.

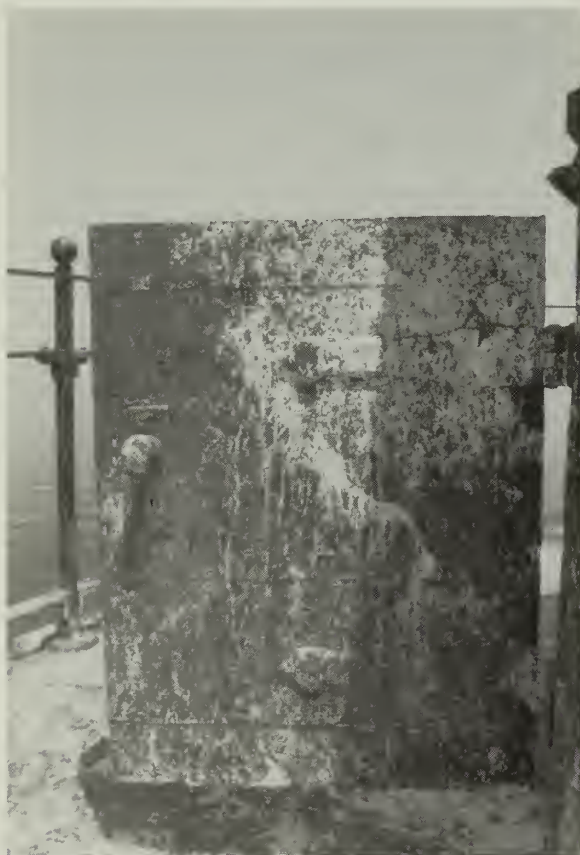
Figure 28. Surfaces such as this sheet-steel-covered parapet door that are covered with seagull guano should be thoroughly cleaned before mothballing and should be checked and cleaned once a year during the mothballing period.

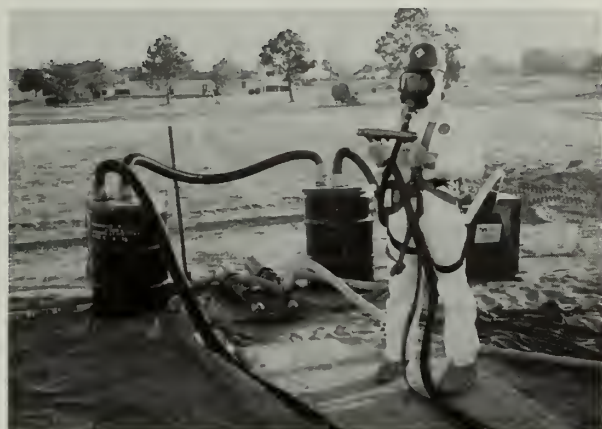
Figure 29. Worker dressed in full personal protective gear. The full-face-shield self-contained respirator provides both respiratory and eye protection. The worker is wearing protective coveralls, gloves, and boot covers to prevent lead dust contact. The harness is part of a full protection system. He is holding a pneumatic needle gun that is hooked to a two-stage HEPA (High Efficiency Particulate Air) filtered vacuum system.

outfitted with dust-collection hoods with vacuum hookup. As with any paint removal procedure, personal protective equipment required for health protection should be worn. Typical personal protective equipment includes eye/face protection, respiratory protection, gloves, coveralls, hard hat, and protection from falling if working 6 feet or higher above the ground (see Figure 29).

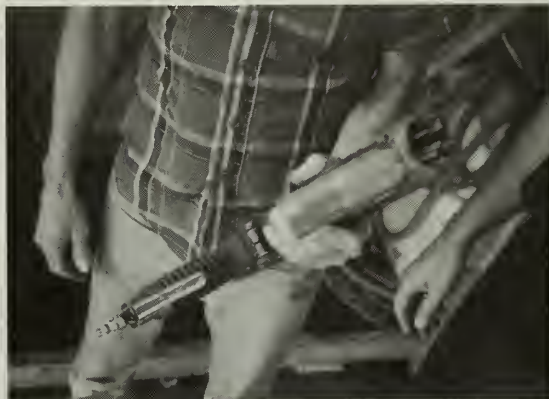
Figure 30. Close-up of a pneumatic needle gun. This tool works well for hard-to-reach and detail areas. The needle gun can be pressure-controlled to minimize impact on the iron substrate. This figure shows the vacuum-shroud connection on the right and air-hose connection on the base of the pistol-grip handle on the left.

Figures 30 through 33 are paint removal tools used during the Sand Key Lighthouse rehabilitation. Sand Key Lighthouse is located in open water off the coast of Key West. The paint being removed contained lead; therefore it was essential that all debris be contained for proper disposal.

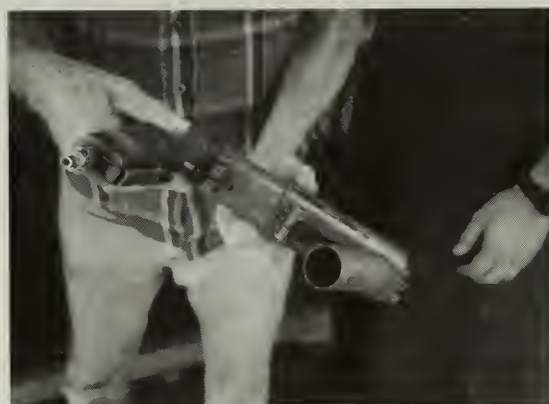
Figure 31. The gun is activated by squeezing the lever on the rubber pistol grip. The amount of air pressure controls the speed and impact of the pulsating needles against the iron substrate. The needles can be seen protruding from the vacuum shroud.

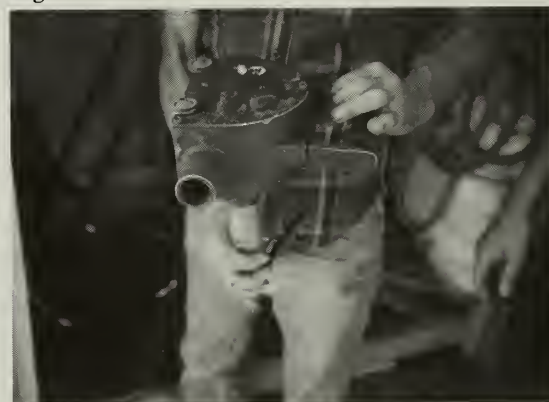
Figure 32. Close-up view of a pneumatic flush-plate tool. During the Sand Key Lighthouse rehabilitation this tool was used for all flat surfaces and for removing paint from the light-tower columns. The rollers located at the top and bottom of the shroud guide the tool over the flat and curved surfaces. The amount of air pressure controls the speed and impact of the rotating head against the iron substrate. To contain the paint dust and chips, the shroud has been outfitted with a vacuum hookup.

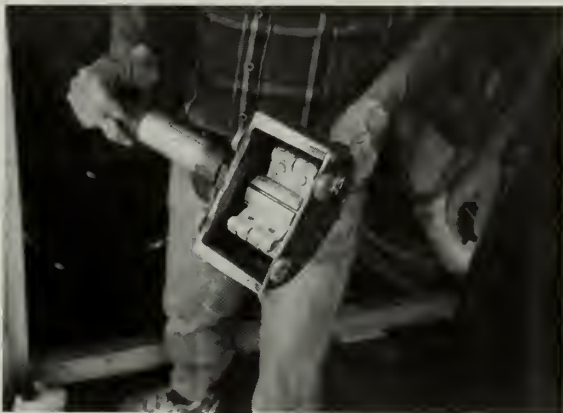
Figure 33. Close-up of the studded flaps mounted on the rotating head. To use the tool, it is held against the face of the iron member and as the studded flaps spin they “slap” the surface and “knock” the paint off the iron.

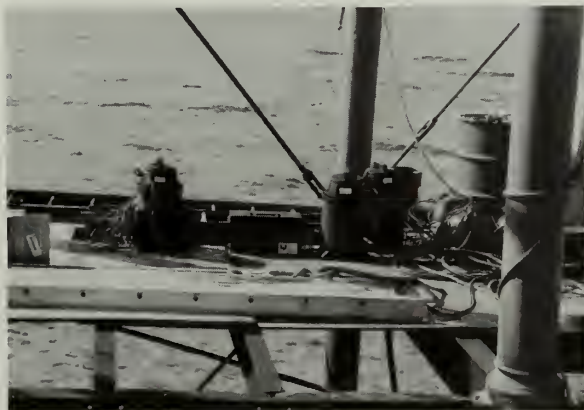
Figure 34. The small vacuums used at Sand Key Light are shown in this photo. Each vacuum has a HEPA filtration system to ensure that no lead dust escaped into the atmosphere. The conditions at Sand Key Lighthouse made the use of a large central vacuum system impractical. Using portable vacuums allowed for paint removal at numerous locations at any one time.

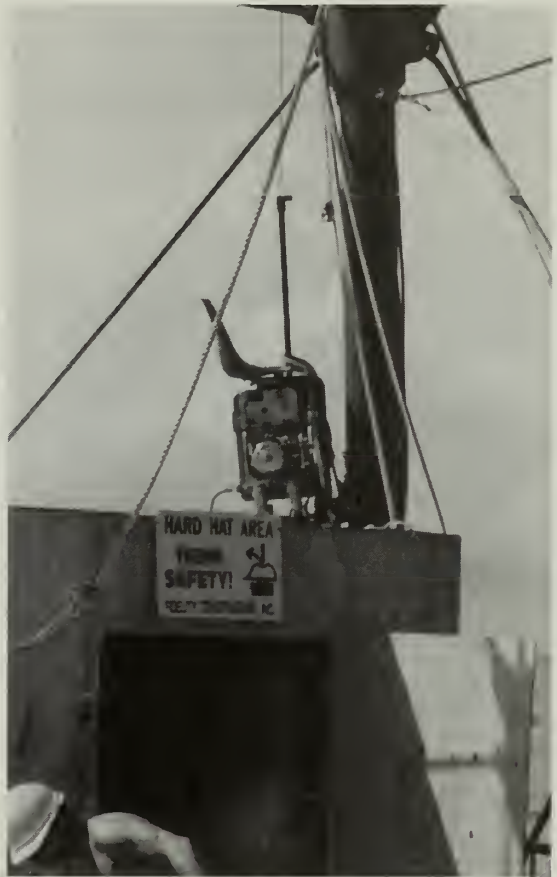
Figure 35. This motorized chair was used to hoist workers as they removed paint from the cast-iron columns at the Sand Key Lighthouse. The chair's motor is attached to a hoist, so the chair actually climbs a cable that has been strung alongside the column.

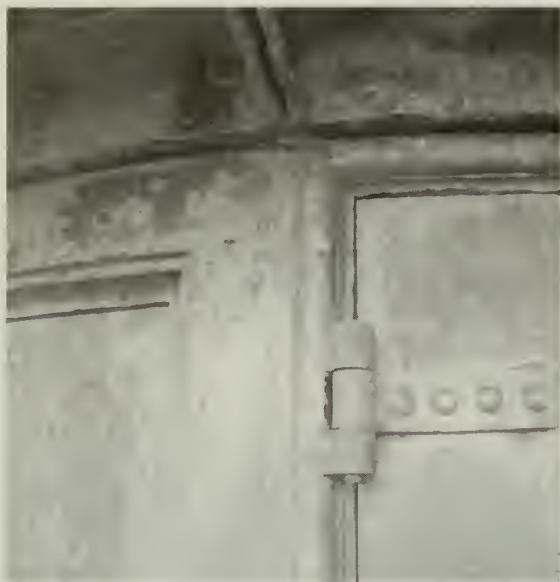
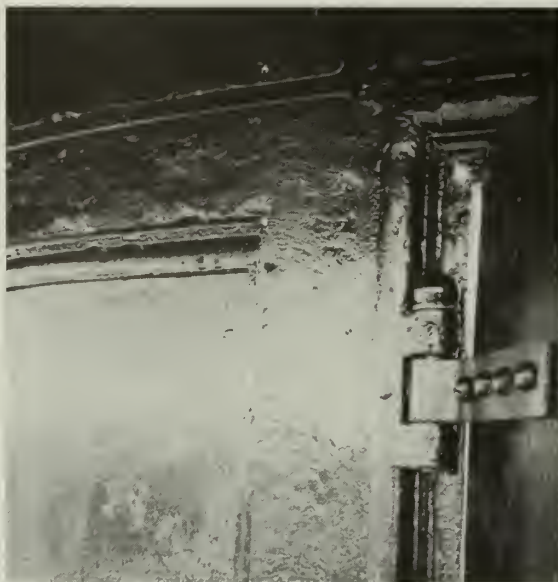
Figures 36 and 37. The left image shows the condition of the iron exterior service room wall before rehabilitation. The right image shows the same area after power hand tool cleaning and coating. The crescent shaped scars in the iron are from the arc of a grinding wheel.

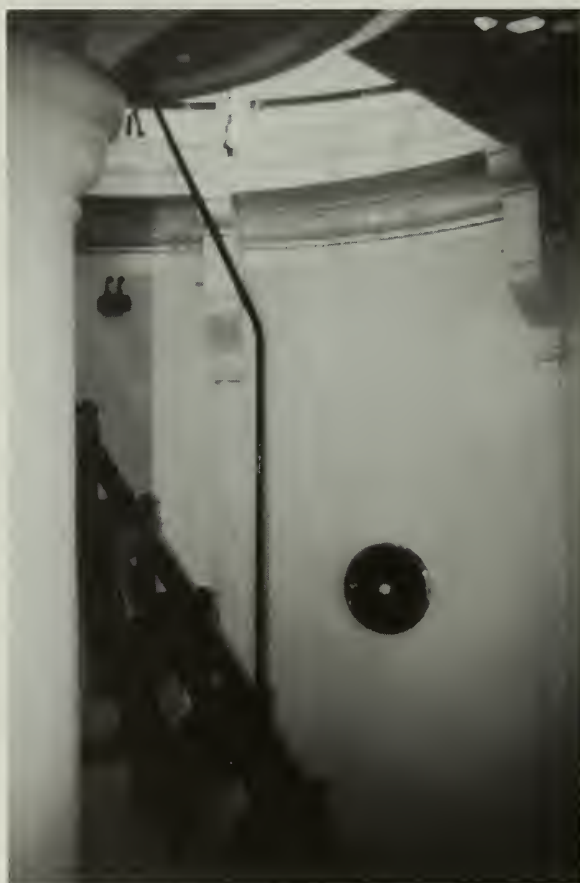
Figure 38. Service room bracket after chemical cleaning.

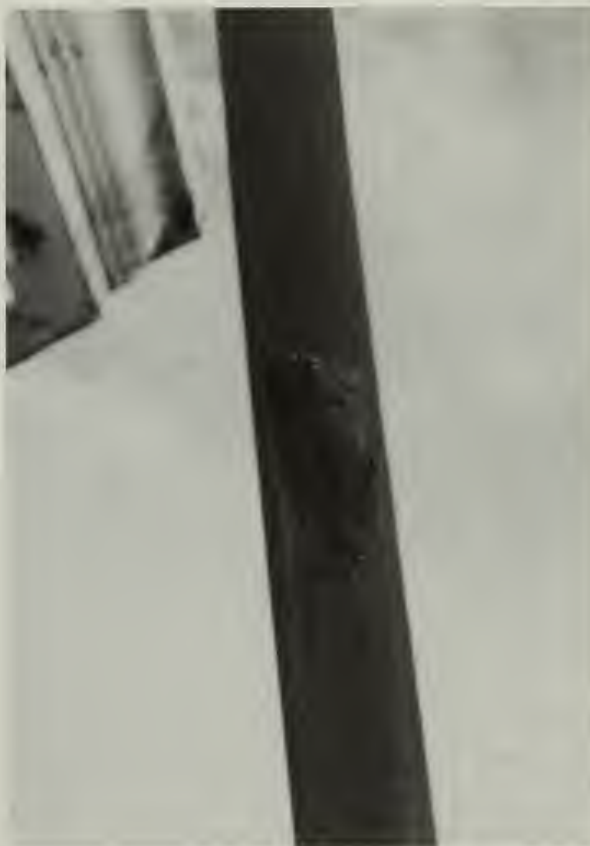
Figure 39. The finish on this tension rod failed and localized corrosion (rust) has formed. The rust is exfoliating in layers that are trapping moisture and causing corrosion to occur deeper and deeper into the tension rod. The result is pitting that will compromise the strength of the tension rod. If the area had been touched up in time, the corrosion might not have formed.

The effective protective life span of an existing paint or coating can be greatly increased by routinely touching up areas of deterioration. A small break in the protective finish can lead to accelerated corrosion of the underlying iron (see Figure 39). Areas where the paint or coating has been damaged by mechanical impact or blistering has occurred should be addressed immediately. These areas should have all loose paint and rust scale removed using one of the recommended methods

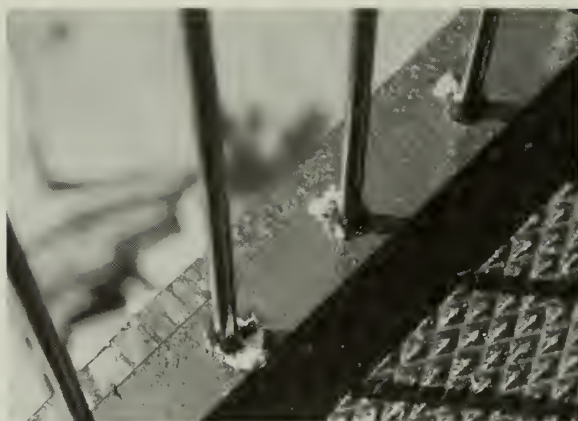
Figure 40. The paint on this stainless steel replacement gallery deck has begun to peel less than three months after it was painted. This could have been prevented if the stainless steel parts were first cleaned and then lightly glass-bead blasted.

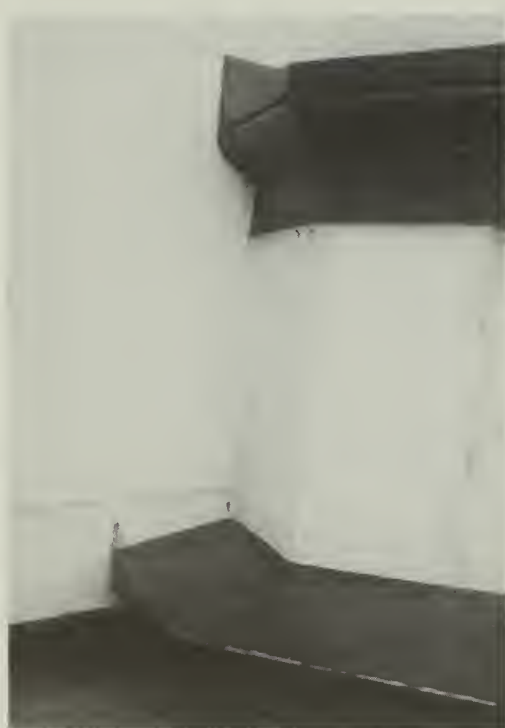
Figure 41 (left). This masonry lighthouse has been detailed with a two-tier cast-iron water table (the iron portions are painted black). Rust-bleed is occurring along lower edge of the upper tier.

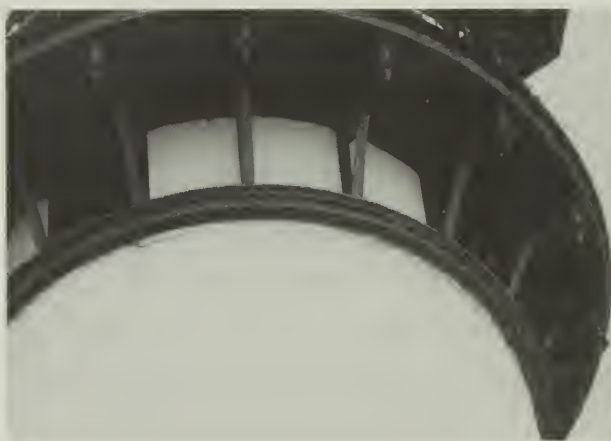
Figure 42 (above). The lower gallery deck of the same masonry lighthouse has rust-bleed occurring along the lower edge of the iron belt course that supports the gallery deck brackets.

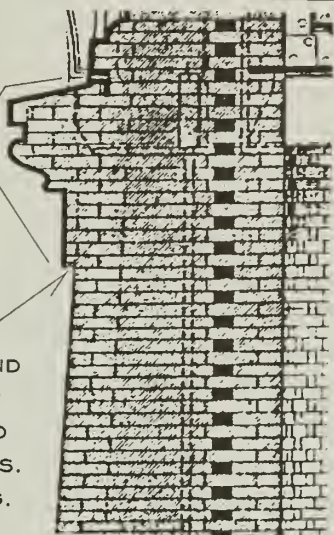
Figure 43.

CAST IRON BELT COURSE

RAKE OUT LOOSE PAINT, MORTAR, AND RUST SCALE. PRIME AND PAINT IRON AND MASONRY (IF PREVIOUSLY PAINTED OR REQUIRED BY SEALANT) SURFACES. SEAL WITH A HIGH QUALITY CAULKING.

This condition can easily be remedied if the following issues are addressed during the preservation treatment of the lighthouse. During any repairs or repainting, all masonry and iron surfaces must be cleaned of all loose paint and rust scale. All mortar that has been placed between the masonry and the iron should also be removed. The mortar helps trap moisture against the iron. Once the joint is clean, all exposed iron must be coated with a rust-inhibiting primer and top coat to provide a barrier between the iron and the mortar. The void created by the missing mortar should be filled with a new mortar mixture that matches the strength of the historic mortar (for more information on the matching of mortar strength refer to the **Masonry** section). When filling the open joint with the mortar, hold the mortar back about 1 inch. The joint should then be filled with a ½-inch-diameter polyethylene foam backer rod. To seal the joint, use a high quality silicone or urethane caulking. (Some caulks may require a painted surface to adhere to brick; therefore, the surface of the brick that will come in contact with the caulk may have to be painted before the caulk is applied). Ideally, the caulking depth should equal the joint depth up to a ½ inch. The profile on the caulking should be slightly concave to shed water. Refer to Figures 43 and 44 for more details.

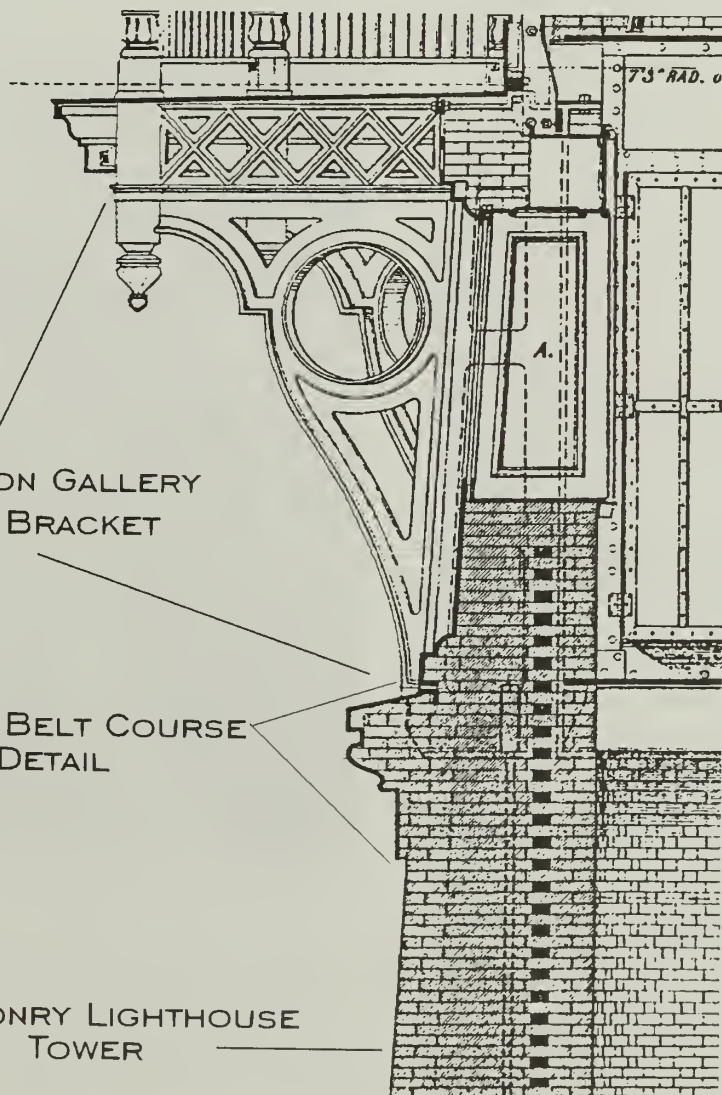
Figure 44.

CAST IRON GALLERY DECK BRACKET

CAST IRON BELT COURSE SEE DETAIL

MASONRY LIGHTHOUSE TOWER

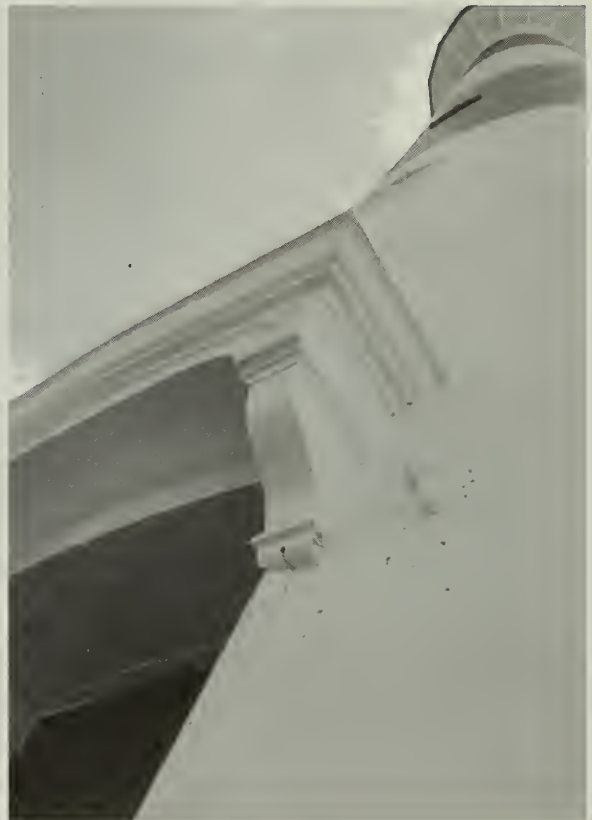
Figure 45. Within three months after painting, the rust began to bleed through this weep hole on the bottom of this pediment bracket. Two lessons are to be learned from this condition: 1) keep weep holes open to allow any water that may have entered the casting to escape, and 2) keep joints around applied castings sealed; apparently this was not done and water has entered the hollow cavity of the pediment, causing rust to form inside.
